Andrew Todd Conservators Ltd.

24 May 2024

Conservation Report Examination and Assessment of Sculptural Installation Ceramic Fins of Centennial Square Fountain City of Victoria

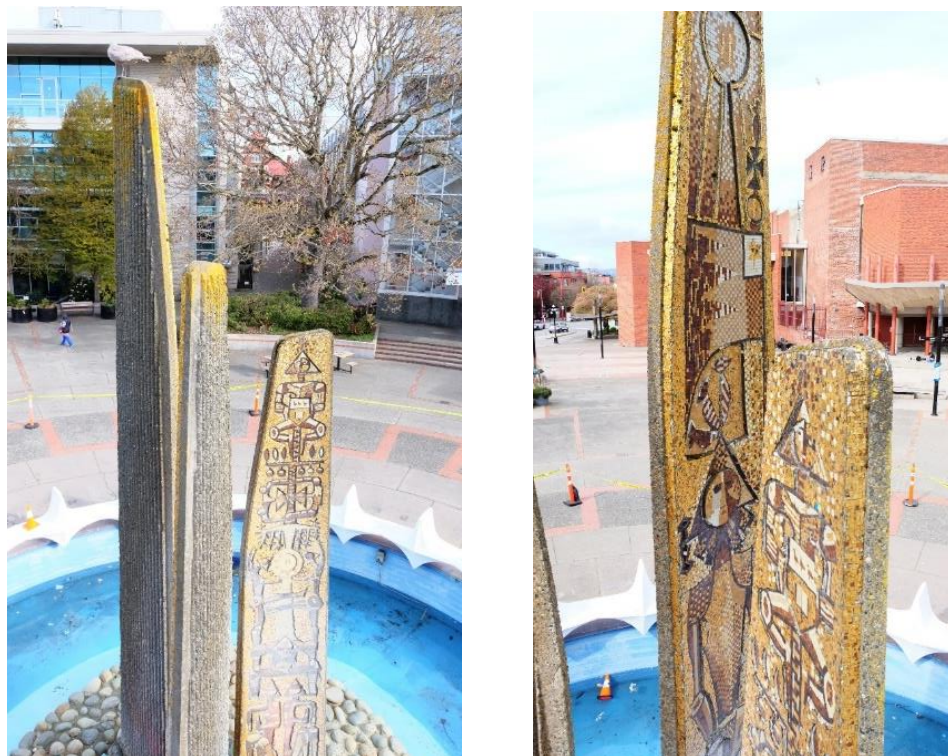
Details of tops of the fin towers reveal a golden yellow moss growth overall.

- 1.) surface deterioration was observed overall, biological surface growths of lichens several kinds of moss, and fungal growths were especially evident across the top half of all 3 fin towers. Tests found that manual removal of surface build-up of moss could be removed by careful scraping with gentle tools followed by slightly stiff brush cleaning. Both the tile surfaces and aggregate backs of the towers were noted to have the same build up of the moss and lichen growths.

- 1.) Treatment of surface biological growths of lichens several kinds of moss, and fungal growths across the top half of all 3 fin towers to be removed by physical brushing of both sides and edges of each tower with gentle tools and soft

- scrapers followed by anionic detergent wash, using similar brushes and then a rinse and followed by a subsequent application of a borate preservative.

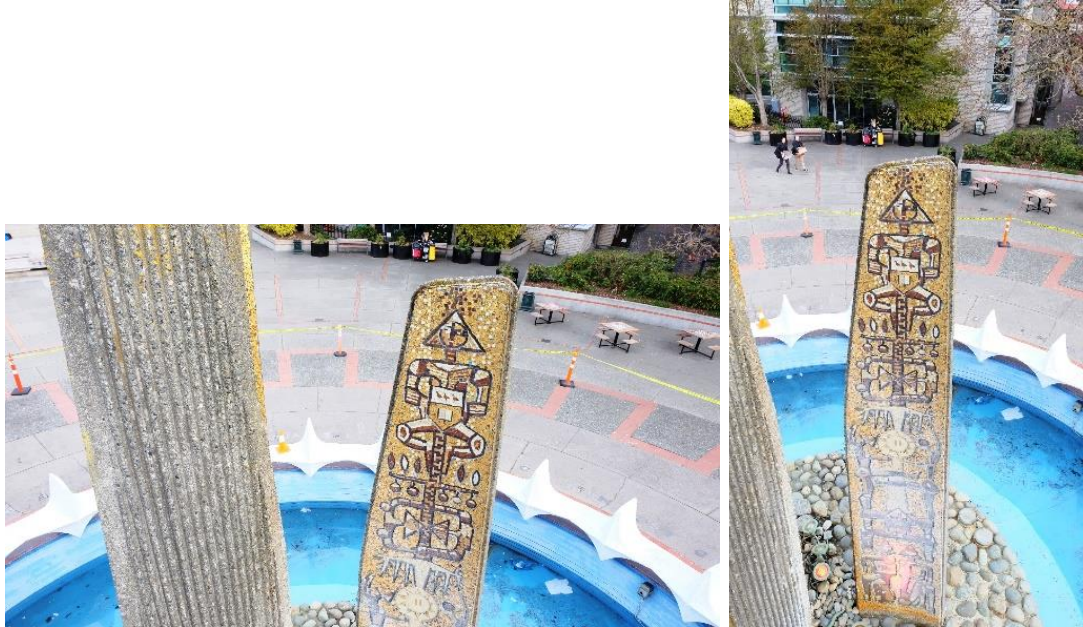
Detail photos of upper areas of the towers. The whitish haze can be observed on the bottom half of the towers and the golden yellow moss/lichen growth on the upper half.

- 9.) Surface images were noted covered by a film of whitish deposit at the base area of the installation. This condition extended upward nearly half the height of the towers. Roughly measured at 10 feet (approx. 3 meters)

- 9.) The surface images that were noted covered by a film of whitish deposit at the base area of the installation is proposed to be treated based on tests following initial overall wash operation for the whole 3 columns of the installation.

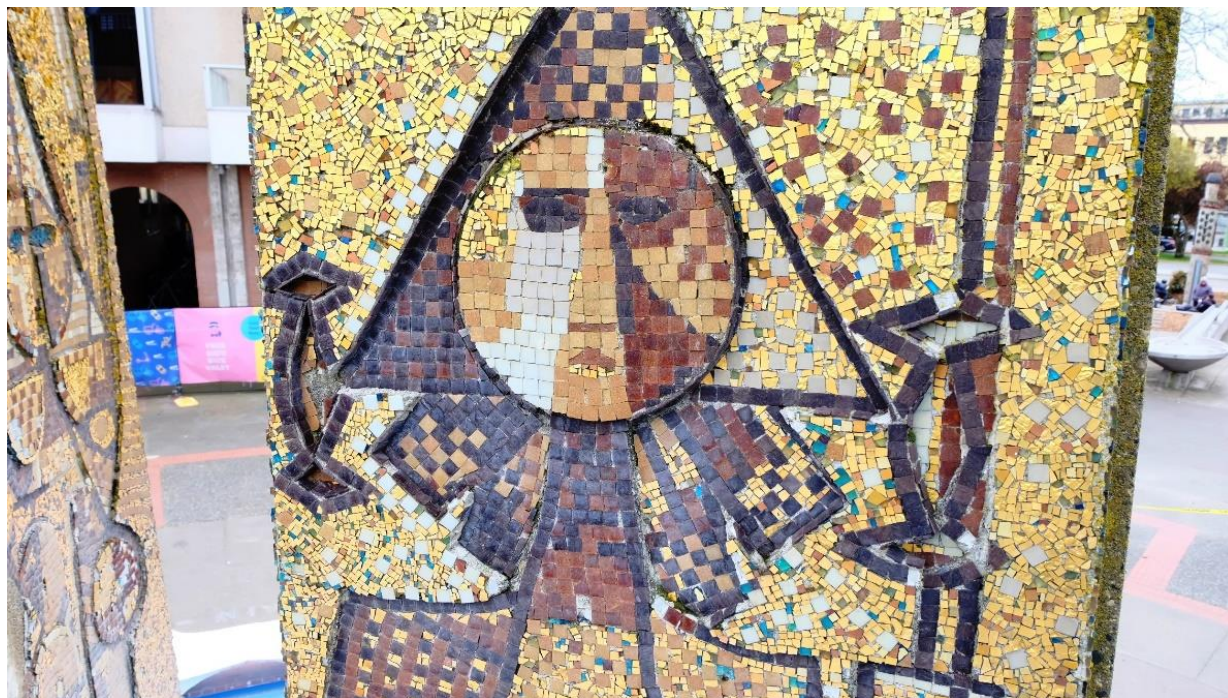
- 4.) Impact damage from contact by projectiles was noted to have caused damage to some individual tiles in a few locations. These are indicated in the photos. Losses of aggregate material noted in fluted backs of each column especially near bases.

Impact damage to tiles noted in this photo.

- 4.) Areas of impact damage to be consolidated at location sites. Repeat consolidation application as required. Preparation of new aggregate concrete to areas with losses. Product; Bentomat, Geosynthetic Clay Liner, (or similar product) and new aggregate concrete material.

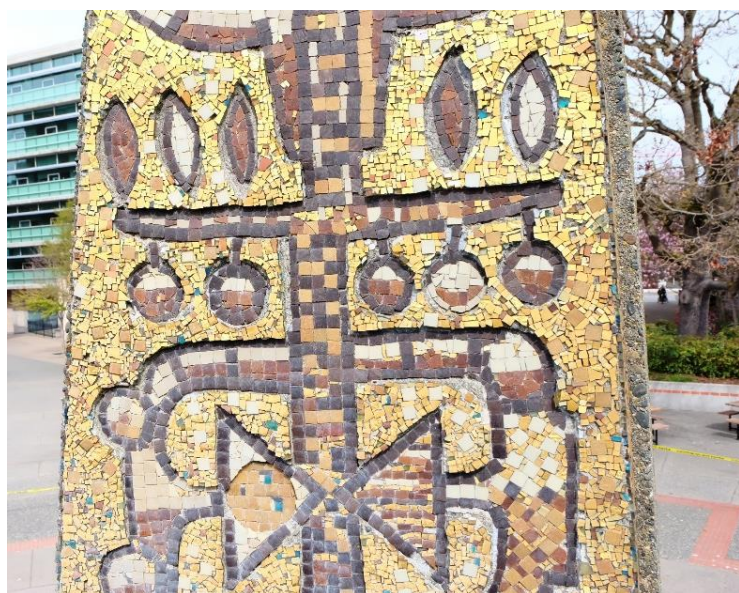
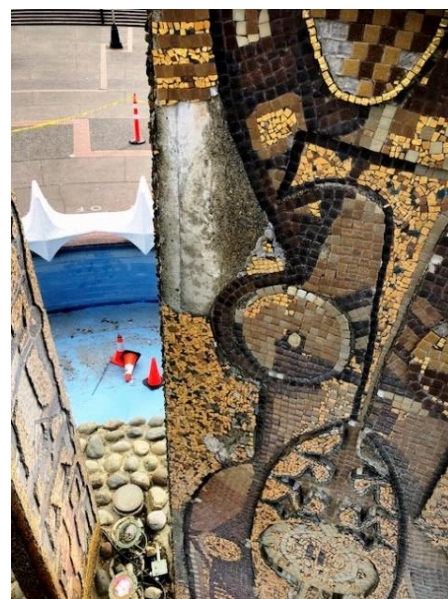
Areas of loss, large area on right photo.

- 5.) Follow surface cleaning with preparation for applying new tiles to resemble existing areas. Repeat process to fill losses. Apply restoration concrete product to aggregate losses on aggregate sides of the 3 columns.

- 6.) Continue application of new tiles and grout as required. Continue application of new aggregate materials to restoration concrete in areas with losses.

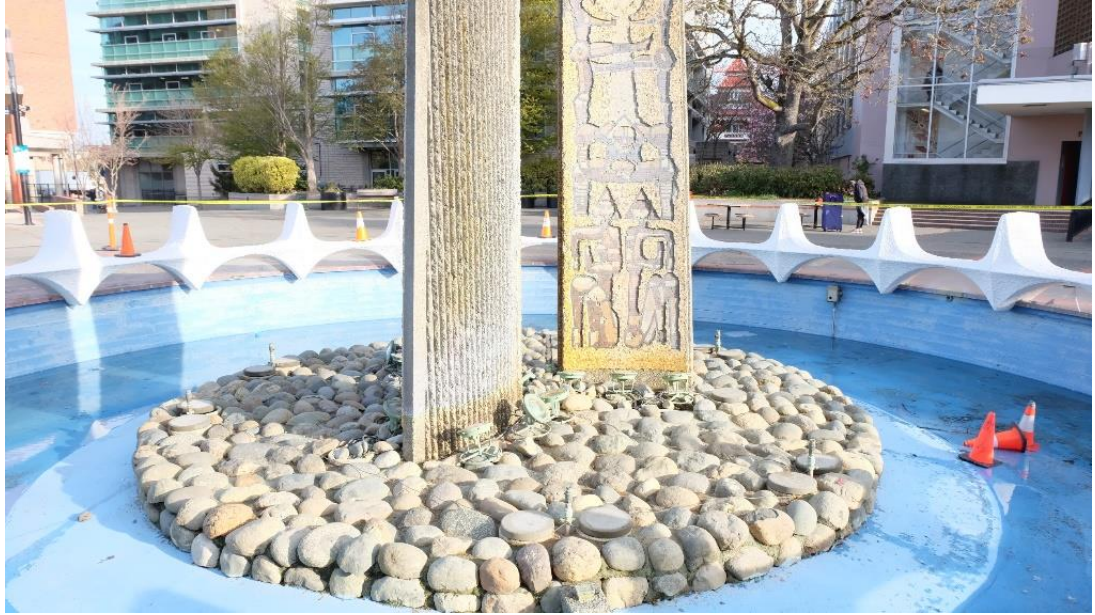
Examination of the base was conducted down to base level of the structures.

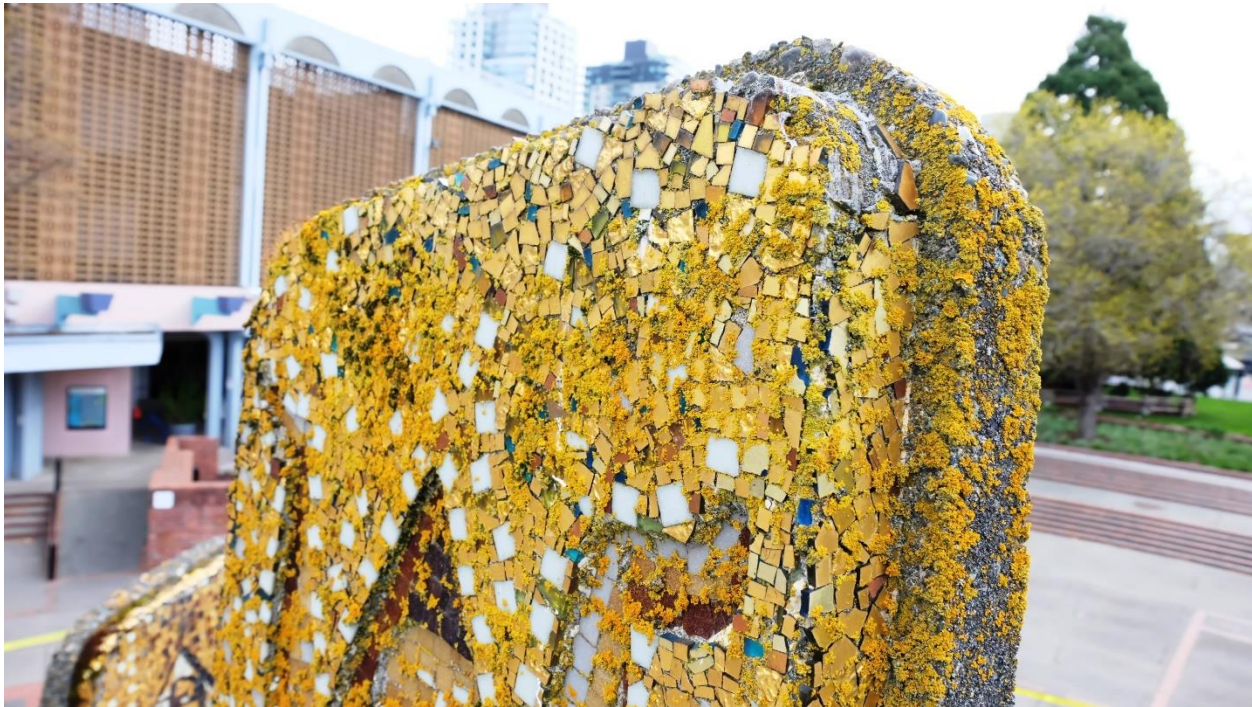
Examination of the upper surfaces found conditions of heavy moss/lichen fungal growths

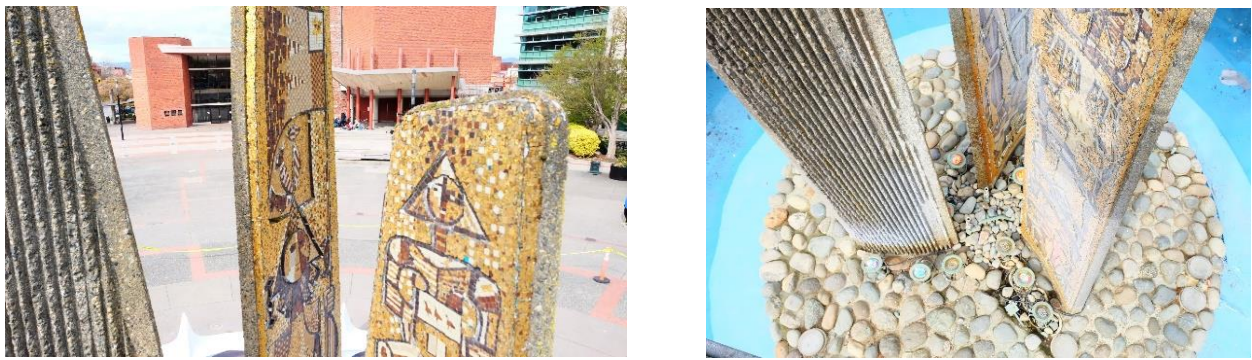
Upper surface conditions on left with moss/lichens. base levels of surface with whitish film.

- 3.) The lower half of all 3 fin towers to be cleaned by wash and rinse followed by tests to determine best removal chemical/acid for the surface build up of additive whitish stains.
